RECORD CLOUDBURST FLOOD IN CARTER COUNTY, TENN., JUNE 13, 1924

By WARREN R. KING, District Engineer, U. S. Geological Survey

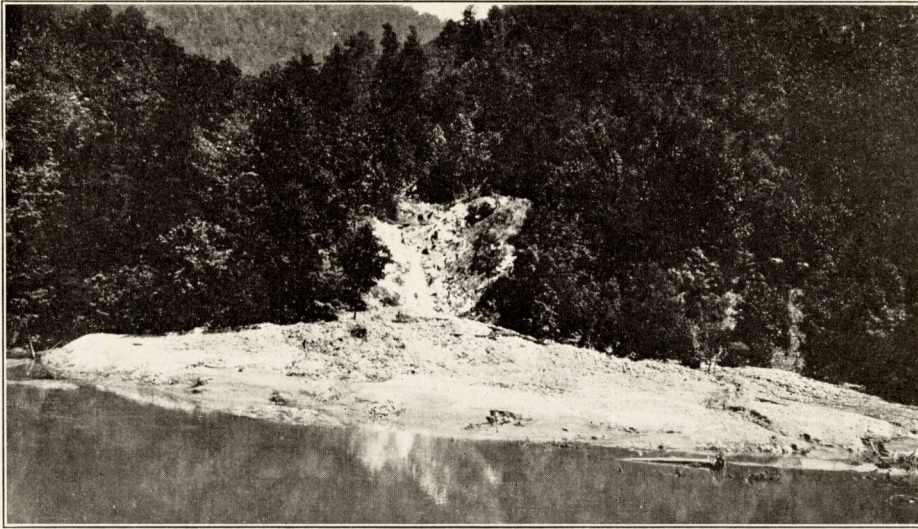
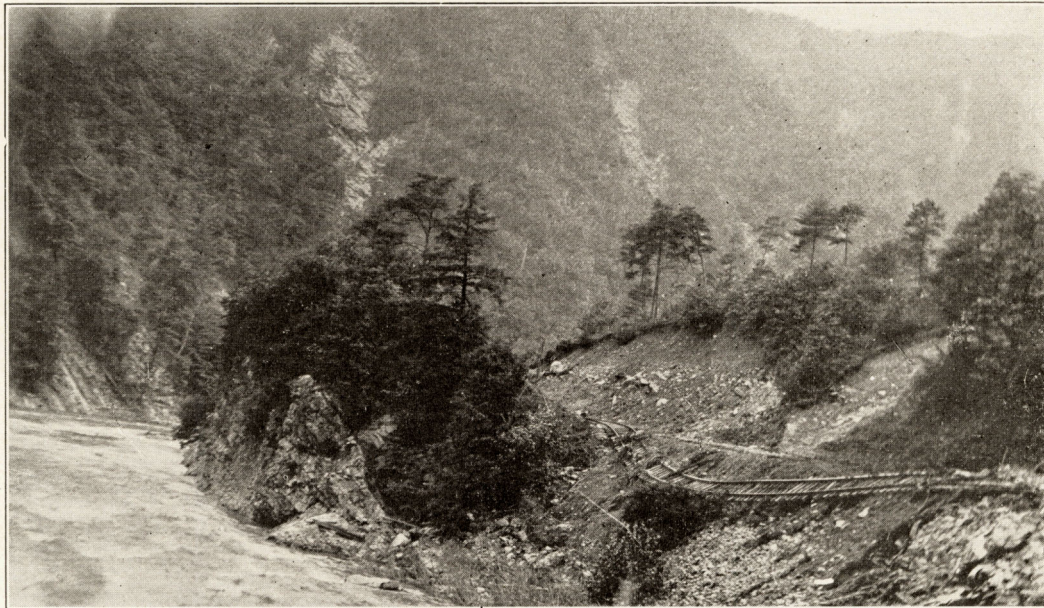
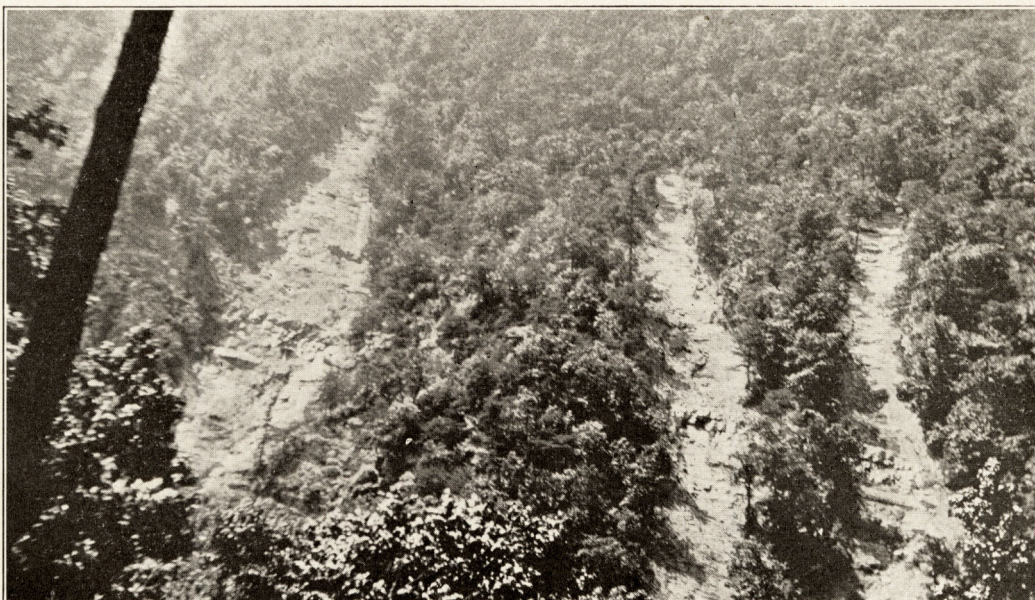
Those who saw the storm say that not only was there a most intense general rain over the region, but that at many places the clouds broke as if punctured and discharged perfect streams of water. The truth of this statement is shown by deep gashes or scars, almost resembling cuts from a hydraulic jet, that were cut into the hillsides at places where there had been no depression or watercourse. The torrents and landslides that cut these gashes carried everything with them to the foot of the slopes, leaving the underlying rock entirely bare. (See figs. 1-3.)

The region is one of very steep slopes and most of it is heavily timbered. A slide once started gained momentum rapidly and struck with tremendous force. Some single slides carried thousands of tons of rock, earth, trees, and debris down to the lowlands and into the river channel. The hillside scars left by these slides range in width from 10 to 100 feet, and from some points no less than a dozen of them can be seen.

The accompanying illustrations (figs. 1, 2, and 3) show something of the force of this record cloudburst and the resulting damage.
